# Results of an RF Pulsed Heating Experiment at SLAC\*

D. P. Pritzkau and R. H. Siemann, Stanford Linear Accelerator Center, Stanford, CA, 94309, USA

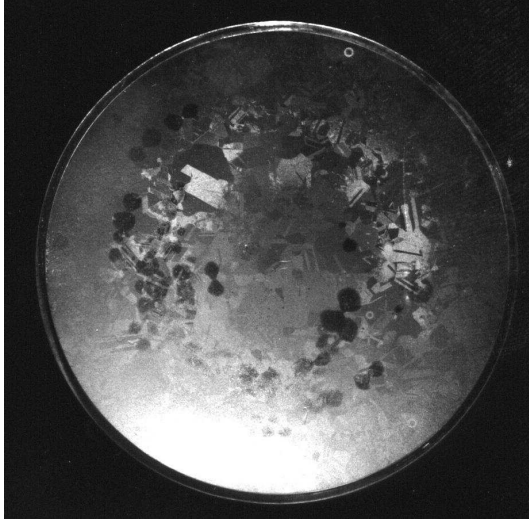
In Figure 1, one can see a visible change in the crystal grains in the region approximately 10.4 mm to 11.0 mm from the center with an average width of approximately 4 mm to 5 mm. From GdifiL [8] simulations, the fields in the region closer to the coupling iris is 5% higher than the fields diametrically opposite of this region. This simulation would then explain why there is more damage in the region closer to the aperture, since the region farther away has a temperature rise approximately 10% lower.

Figure 1: One of the copper endcaps. The other endcaps are similar in appearance.

density of the copper globules increases closer to the plane of the coupling irises. One may also see dark circles along the area of maximum magnetic field. Since they seem to occur in pairs and the magnetic field in this area is radial, we believe these patches are due to multipacting. However, it is not yet understood why this occurs since the electric field in this region is zero.

Each endcap was scanned along a random diameter. The scans show that cracks are only evident in the region of visible grains in Figure 1 where maximum damage is expected. Higher magnification images of the regions of cracks were

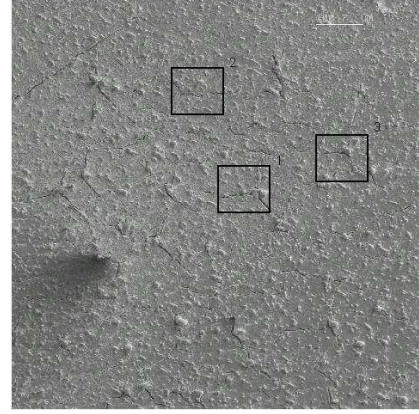
The endcaps were examined with a scanning electron microscope using secondary emission and a 5 keV electron beam. Figure 2 shows a region where maximum damage is expected. Note that this endcap pictured is different from the one shown in Figure 1; however, all four endcaps are similar in appearance. The little bumps along the surface are the copper globules sputtered from breakdown at the coupling iris. More importantly, one can easily see the numerous cracks that have occurred on the surface. For comparison, a region at the center where the temperature rise is close to zero is shown in Figure 3. This picture was taken at the same magnification. There are no cracks in this region. The copper globules are also noticeable here. Because of the sputtering, we cannot isolate the unloaded Q degradation shown in Table 1 due to sputtering from that due to the presence of the cracks.

Figure 2: Region (0.9 mm  $\times$  0.9 mm) where maximum damage is expected. The scale in the upper right-hand corner is 100.7  $\mu\text{m}$ . Figure 4 has higher magnification images of the indicated regions.

taken. For the endcap shown in Figure 2, the average location of all higher-magnification images of cracks is approximately 10.4 mm from the center with a standard deviation of 1.3 mm. Close-up shots of a few of these cracks are shown in Figure 4.

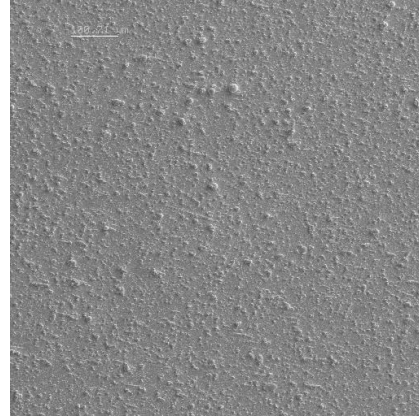
Figure 3: Center of endcap. The scale in the upper left-hand corner is 100.7  $\mu\text{m}$ .

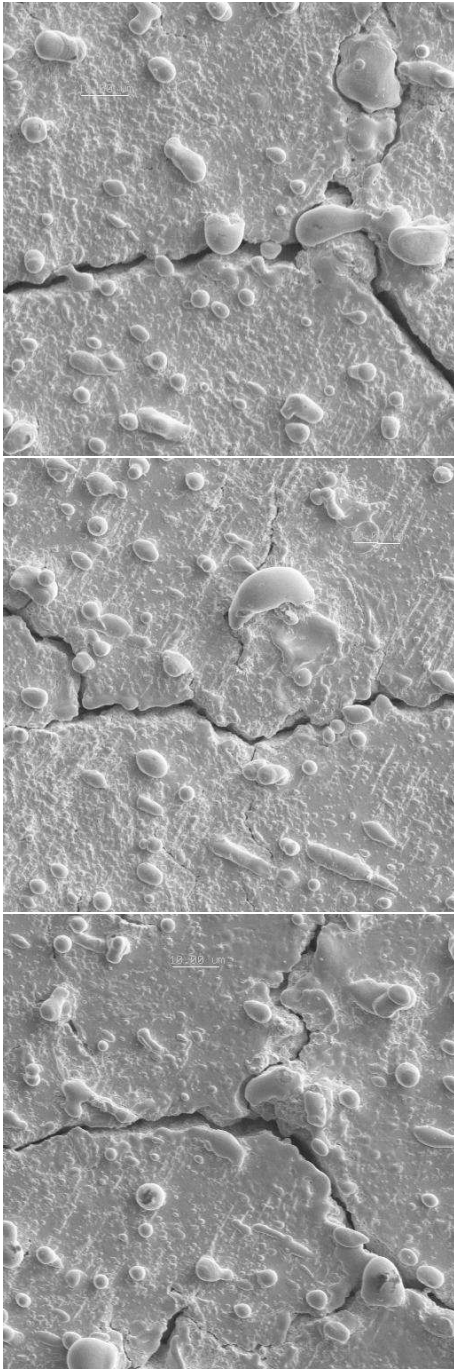
Figure 4: Regions 1–3 from Figure 2. The scale shown in each image is  $10.0\ \mu\text{m}$ .

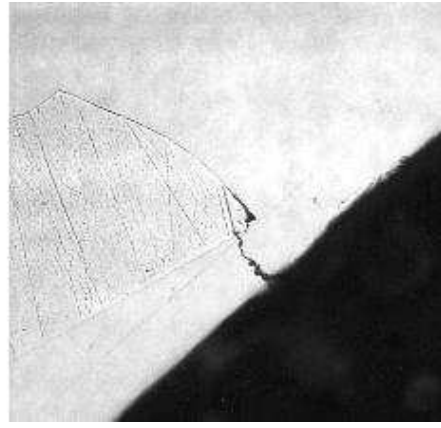
An internal cross-section of the endcap shown in Figure 1 was completed. Not as many cracks were evident in the cross-section, but they did occur in the region of maximum temperature rise. One interesting crack is shown in Figure 5. It begins at the surface and propagates down to an internal grain boundary. Afterwards, the crack propagates along the grain boundary.

Figure 5: A cross-section of the endcap shown in Figure 1 showing an internal crack in the region of maximum temperature rise. The crack extends  $24\ \mu\text{m}$  into the surface before touching the grain boundary.
